Instructions to Replace Thermostat v.1.

These notes to assist Service Engineers in the procedure for replacing thermostats in Shoreline refrigerators and should be read in conjunction with any other specific instructions that may have been given by SHORELINE (UK) LTD.

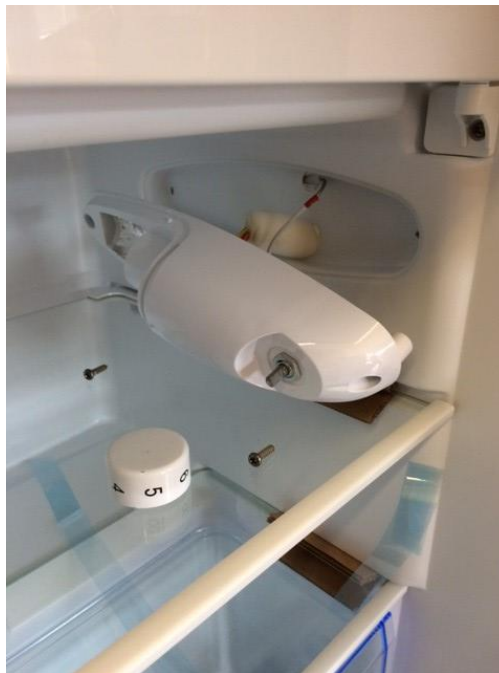
The thermostat housing is secured in place with 2 x screws, one of these often being concealed under the interior light cover. The interior light cover will have to be removed to access the rear thermostat housing screw.

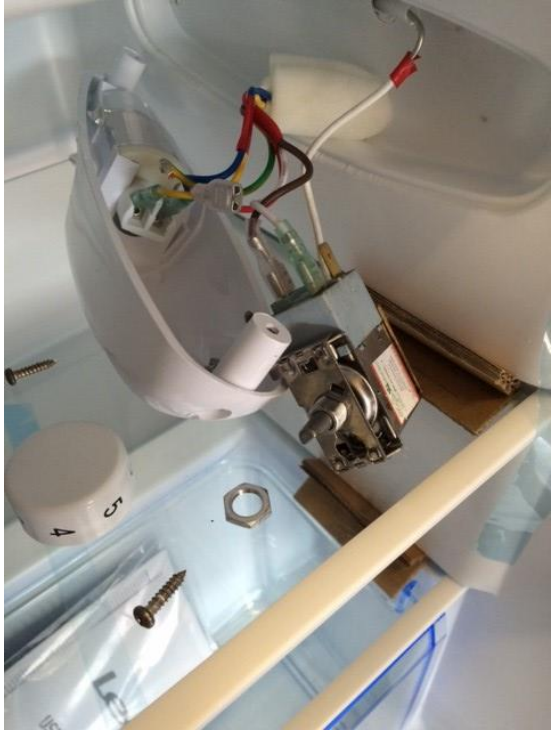
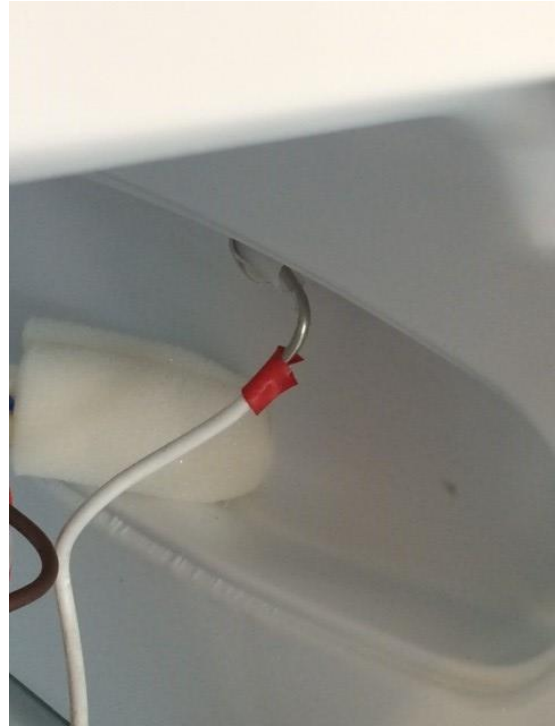
The thermostat body will need to be removed by first removing the thermostat numbered knob on the front of the housing by simply pulling or prising off the D shaped thermostat body spindle. Once this is removed the thermostat body can be removed from the plastic housing by undoing the hexagonal threaded nut.

Make a note of where the wired spade connections are placed on the thermostat body (usually across terminals marked 3 & 4 dependent upon thermostat type) before removing them. The thermostat sensing phial (the long thin aluminium tube) can then be pulled right out of the refrigerator body.
